Arborist Report

PROTECTED TREE REPORT
for
the Meadows at Bailey Canyon Project
City of Sierra Madre, California

DUDEK

NOVEMBER 2020

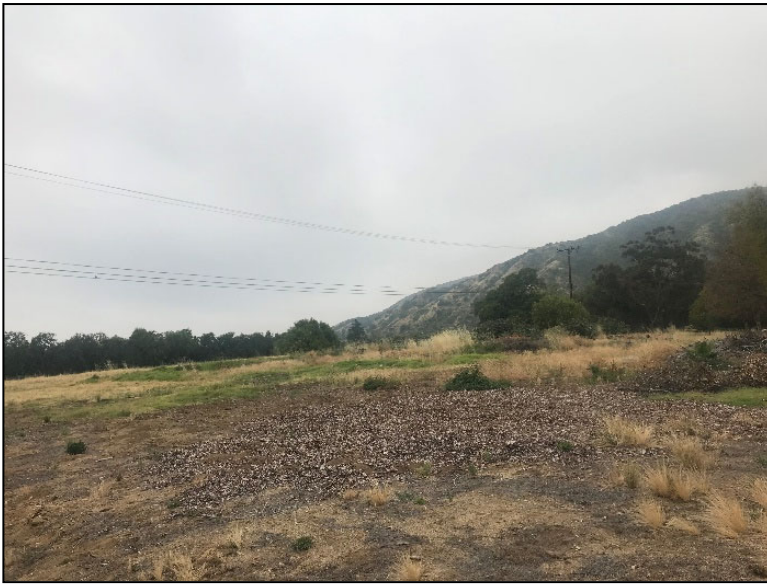
Photo 1. Representative site photograph facing north.

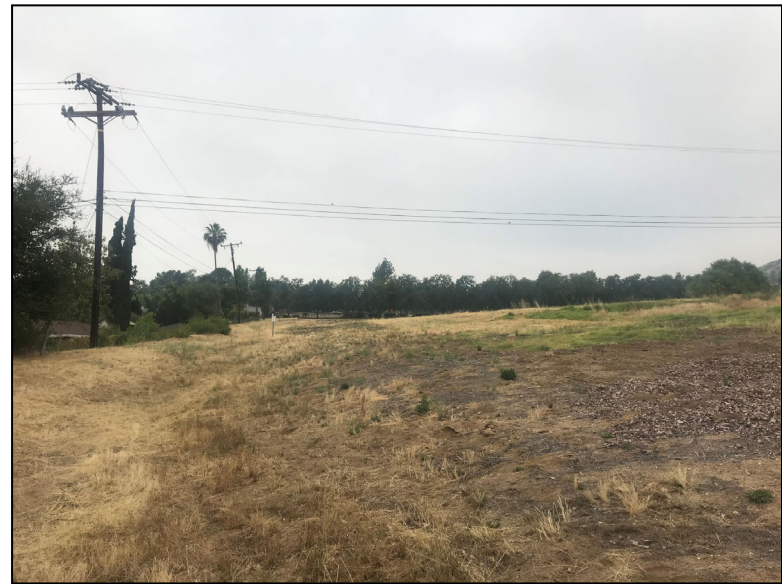
Photo 2. Representative site photograph facing west.

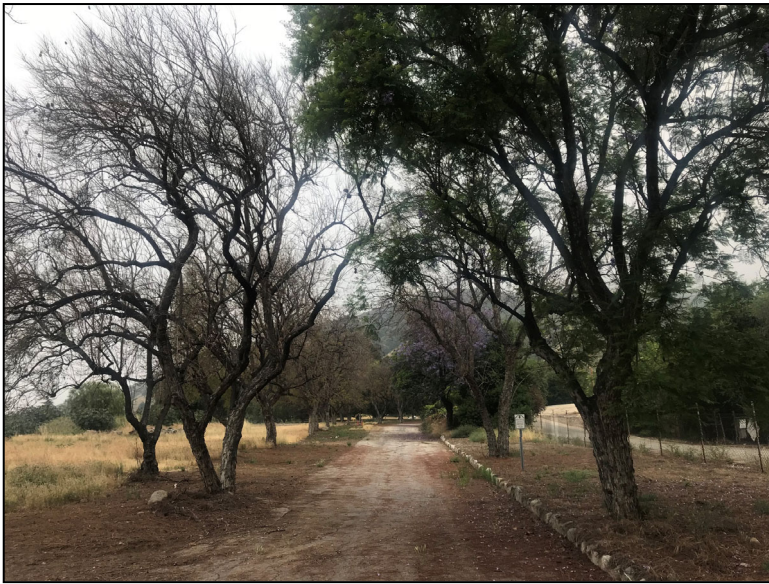
Photo 3. Representative site photograph of trees lining the driveway on the east side of property.

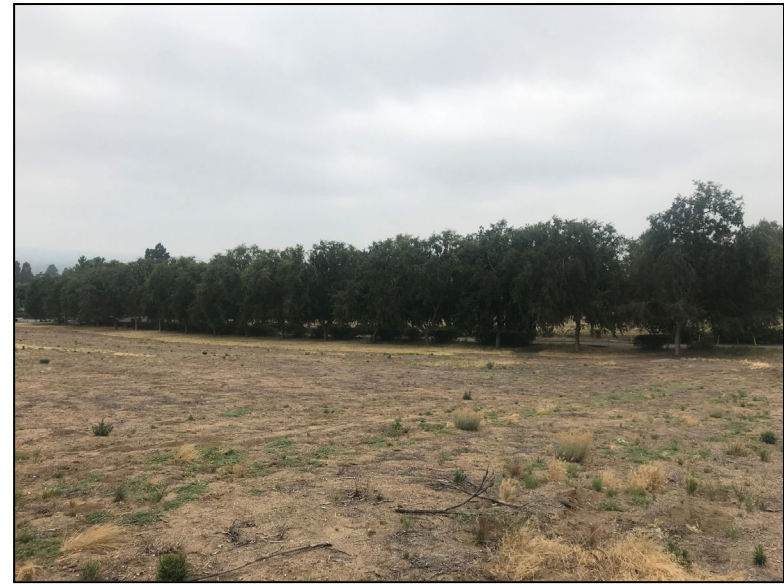
Photo 4. Representative site photograph of trees lining the driveway on the west side of property.

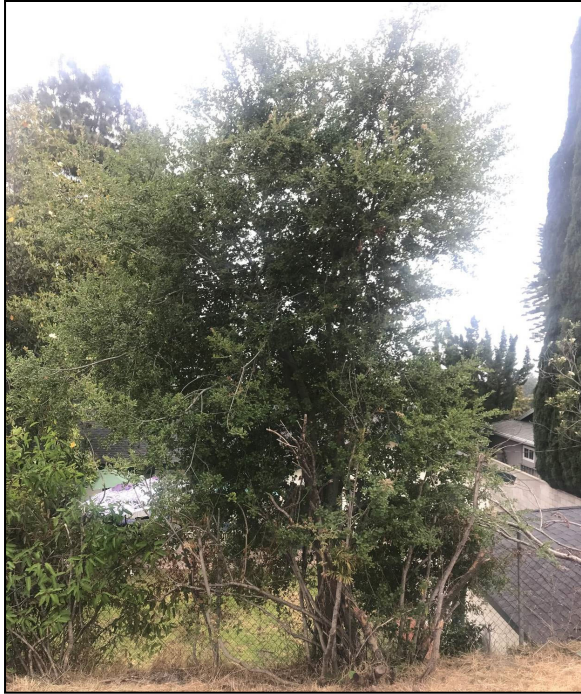
Photo 5. Photograph of protected coast live oak tree #1.

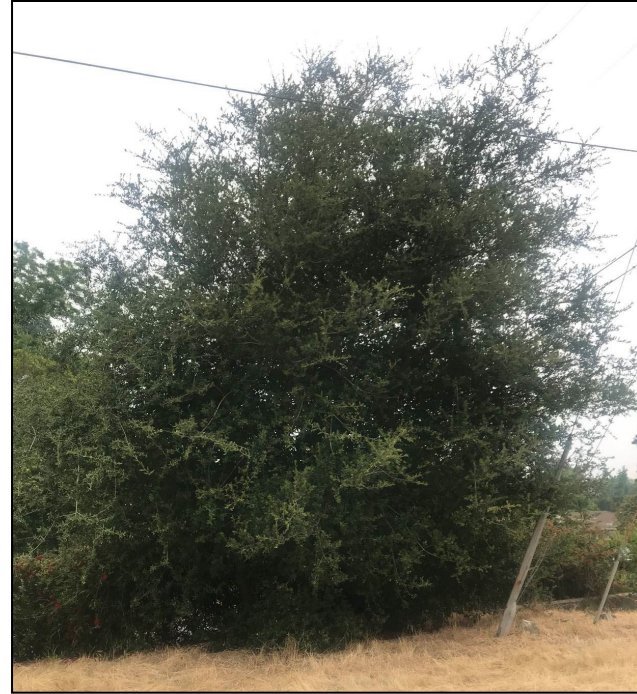
Photo 6. Photograph of protected coast live oak tree #2.

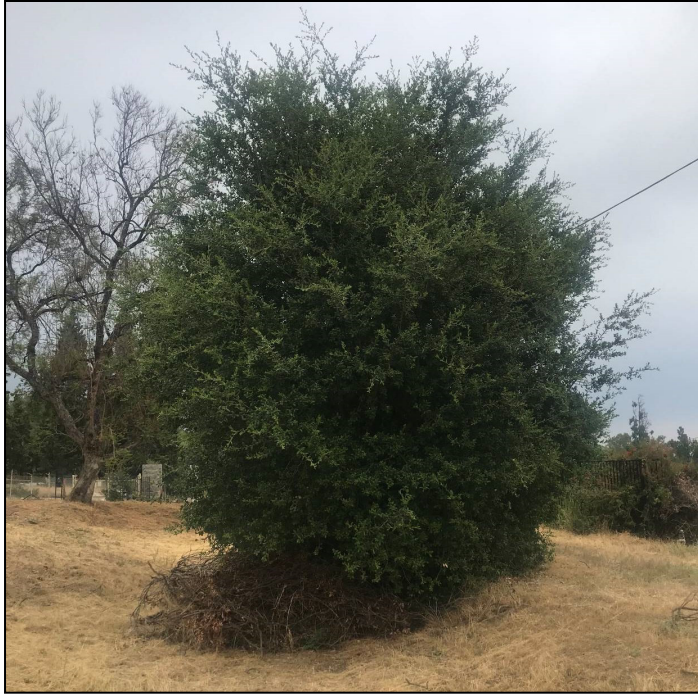
Photo 7. Photograph of protected coast live oak tree #3.

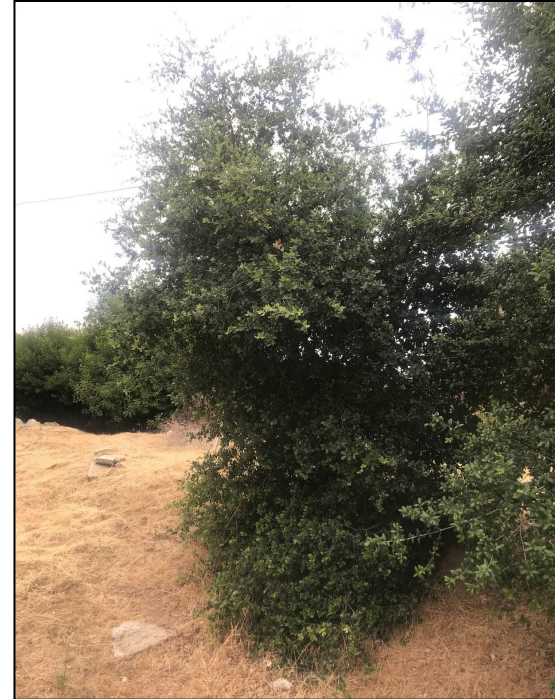
Photo 8. Photograph of protected coast live oak tree #4.

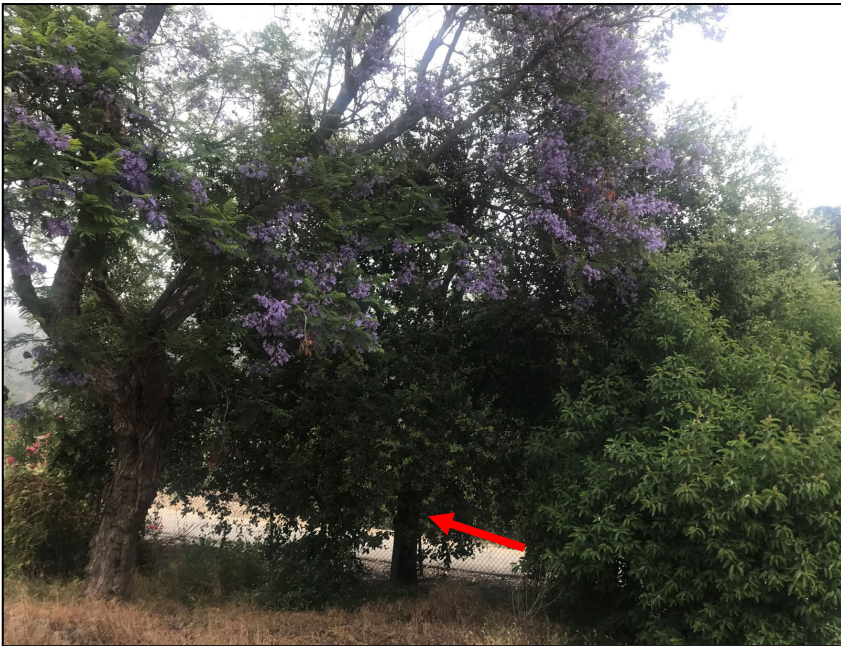
Photo 9. Photograph of protected coast live oak tree #15.

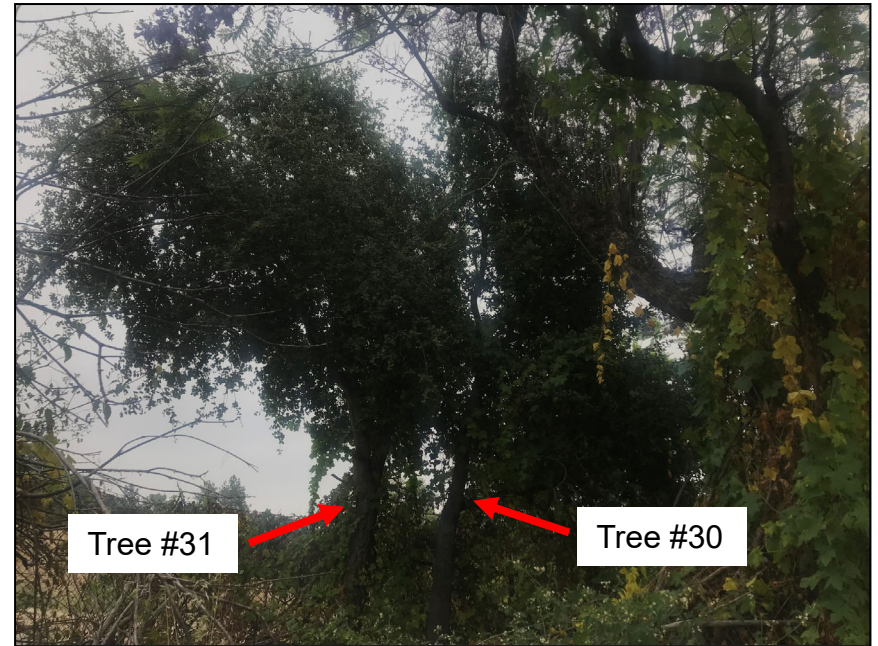
Photo 10. Photograph of protected coast live oak trees #30 and #31.

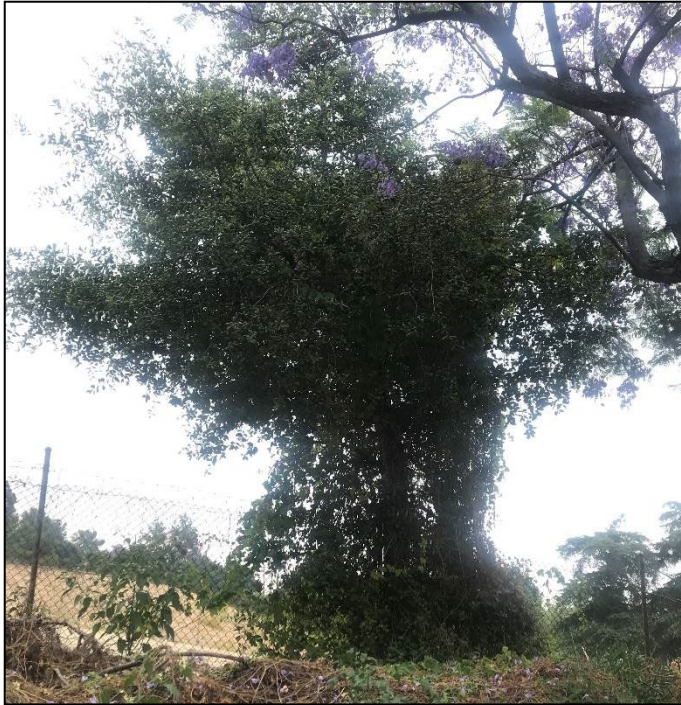
Photo 11. Photograph of protected coast live oak tree #33.

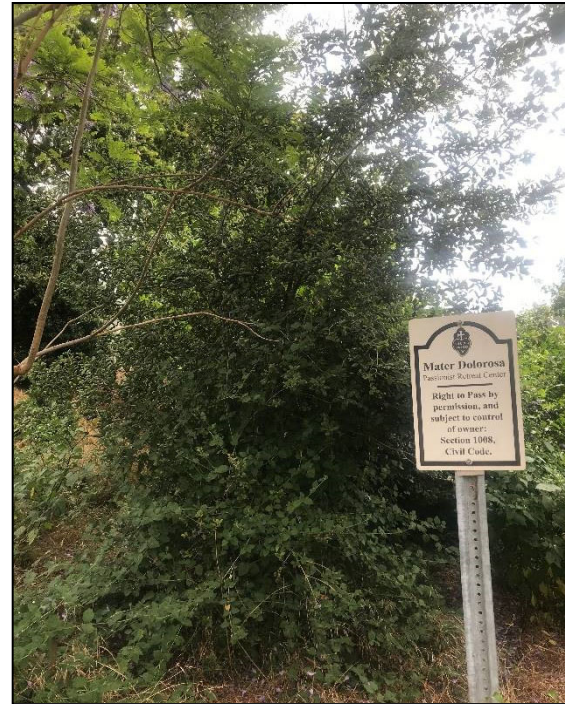
Photo 12. Photograph of protected coast live oak tree #43.

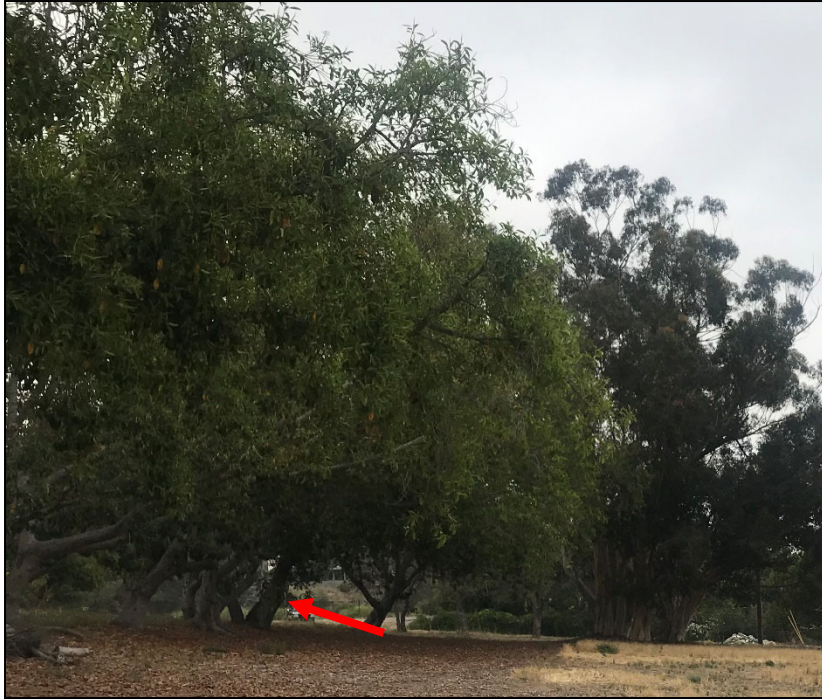
Photo 13. Representative photograph of protected coast live oak tree #61.
